WORKING WITH NATURE TRAINING SERIES

Designing with nature-based solutions in rural areas and open space

LOUISIANA WATERSHED INITIATIVE

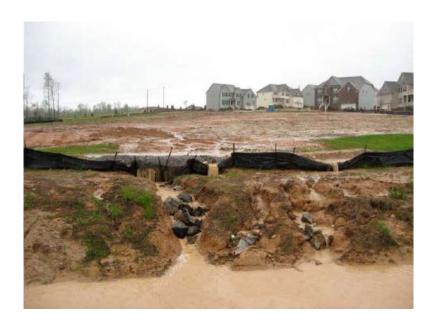
Upland/hillslope vs. in-channel sediment loads

Sediment from stream channels account for as much as 85% of watershed sediment yields, and streambank retreat rates as high as 24 feet per year have been documented (Simon, A. et al, 2000).

1 acre x 2" erosion over 1-year period = 270 cubic yards x 1.1 tons/cy = 295 tons/year

210' long x 15' tall eroding failing/retreating channel bank (12' over 6 months) = 1,400 cubic yards = 1,540 tons = 3,080 tons/year

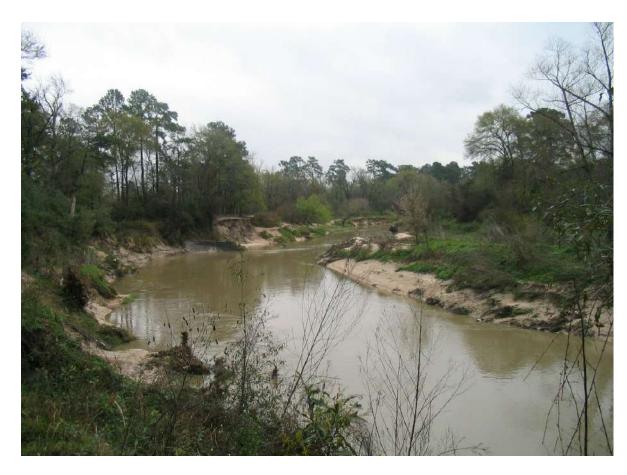
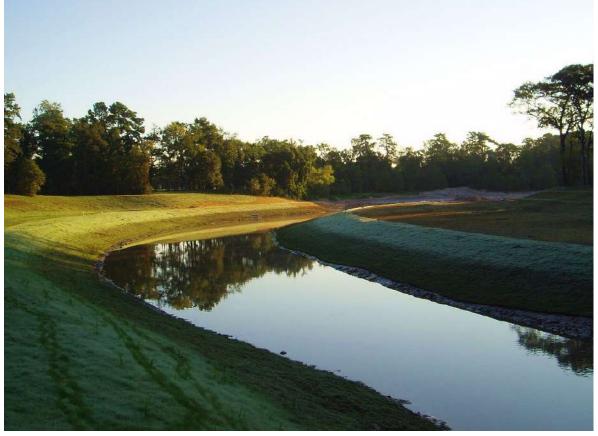
Before and after (2006)

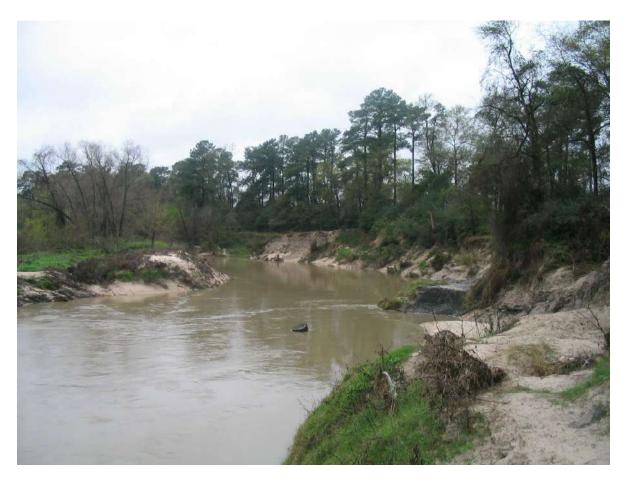
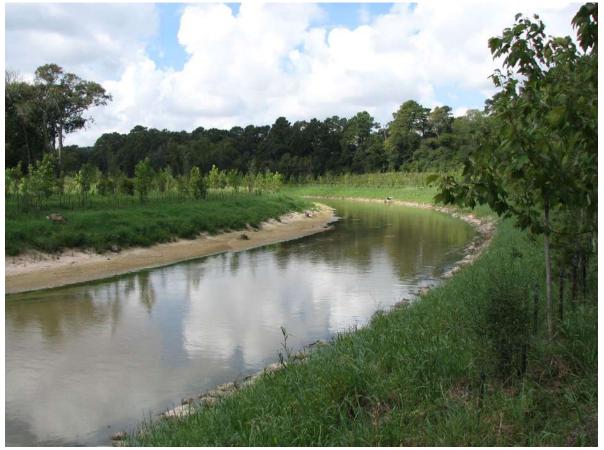
Before and after (2009)

STABLE AND SELF-IMPROVING AFTER 8 BANKFULL EVENTS

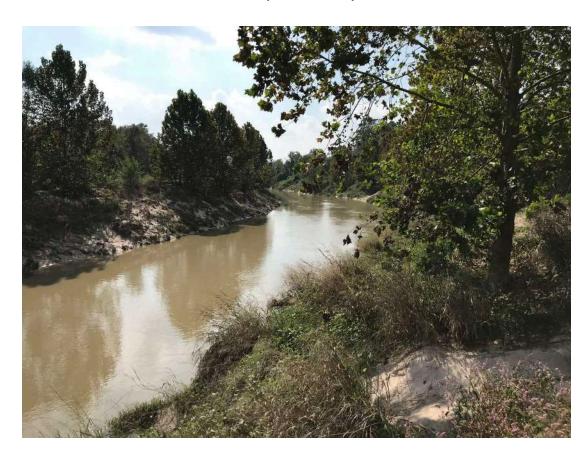
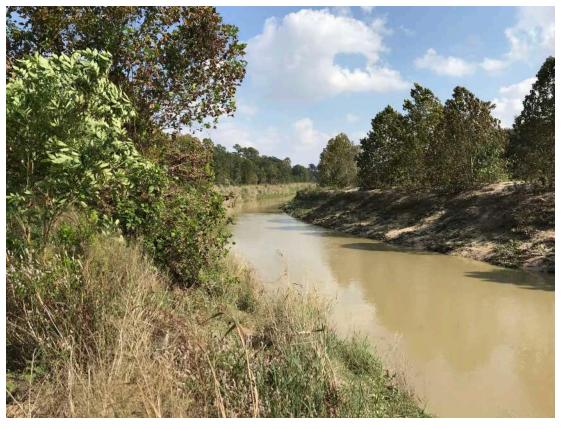
11 years later (2017)

STABLE AND SELF-IMPROVING AFTER MEMORIAL DAY FLOOD (2016), TAX DAY FLOOD (2016) AND HURRICANE HARVEY (2017)

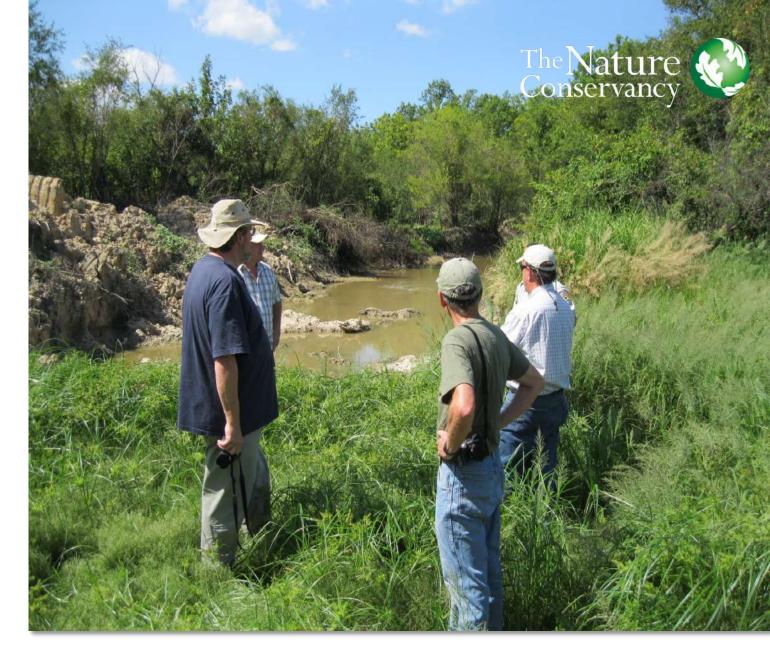
Levee breach plan

- A design of the location and dimensions of the breaches was created to minimize the potential of scour and head-cutting during flood recession.
- The breaches were positioned to facilitate floodplain flow and water exchange between the Ouachita River and Mollicy Farms.
- The U.S. Army Corps of Engineers granted a permit to the USFWS for the breach design.

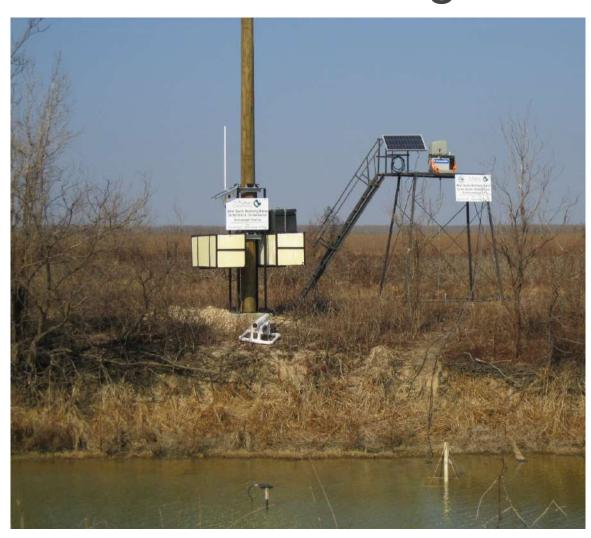
Water monitoring stations

Parameters measured:
